Executive Summary

This project comprises 50 Family units in 4-2 story wood framed walk-up buildings. Built in 1981, Ka Hale Kahaluu was completely renovated in 2007. All asbestos was abated at that time. The Manager's Building was also completely renovated, as was the laundry. The laundry was originally part of the Manager's Building; it was split into two laundries, one attached to Building 1 on the upper level and one attached to Building 3 on the lower level. Four units were renovated to be fully accessible; portions of the site access and parking were also modified to meet accessibility requirements. Most of the Deficiency Costs of \$8,118 were rectified by the renovation Contractor subsequent to the One-Year Warranty Inspection. The first projected Capital Costs are for 2013 for \$466,125 for interior and exterior painting.

This project comprises 32 Elderly units in 4-2 story concrete and masonry walkup buildings. Built in 1981, the project has not been renovated. Many of the major project elements have reached the end of their useful life and require replacement. There are significant repairs that are required, as indicated by the Deficiency Costs of \$276,927. Almost 80% o

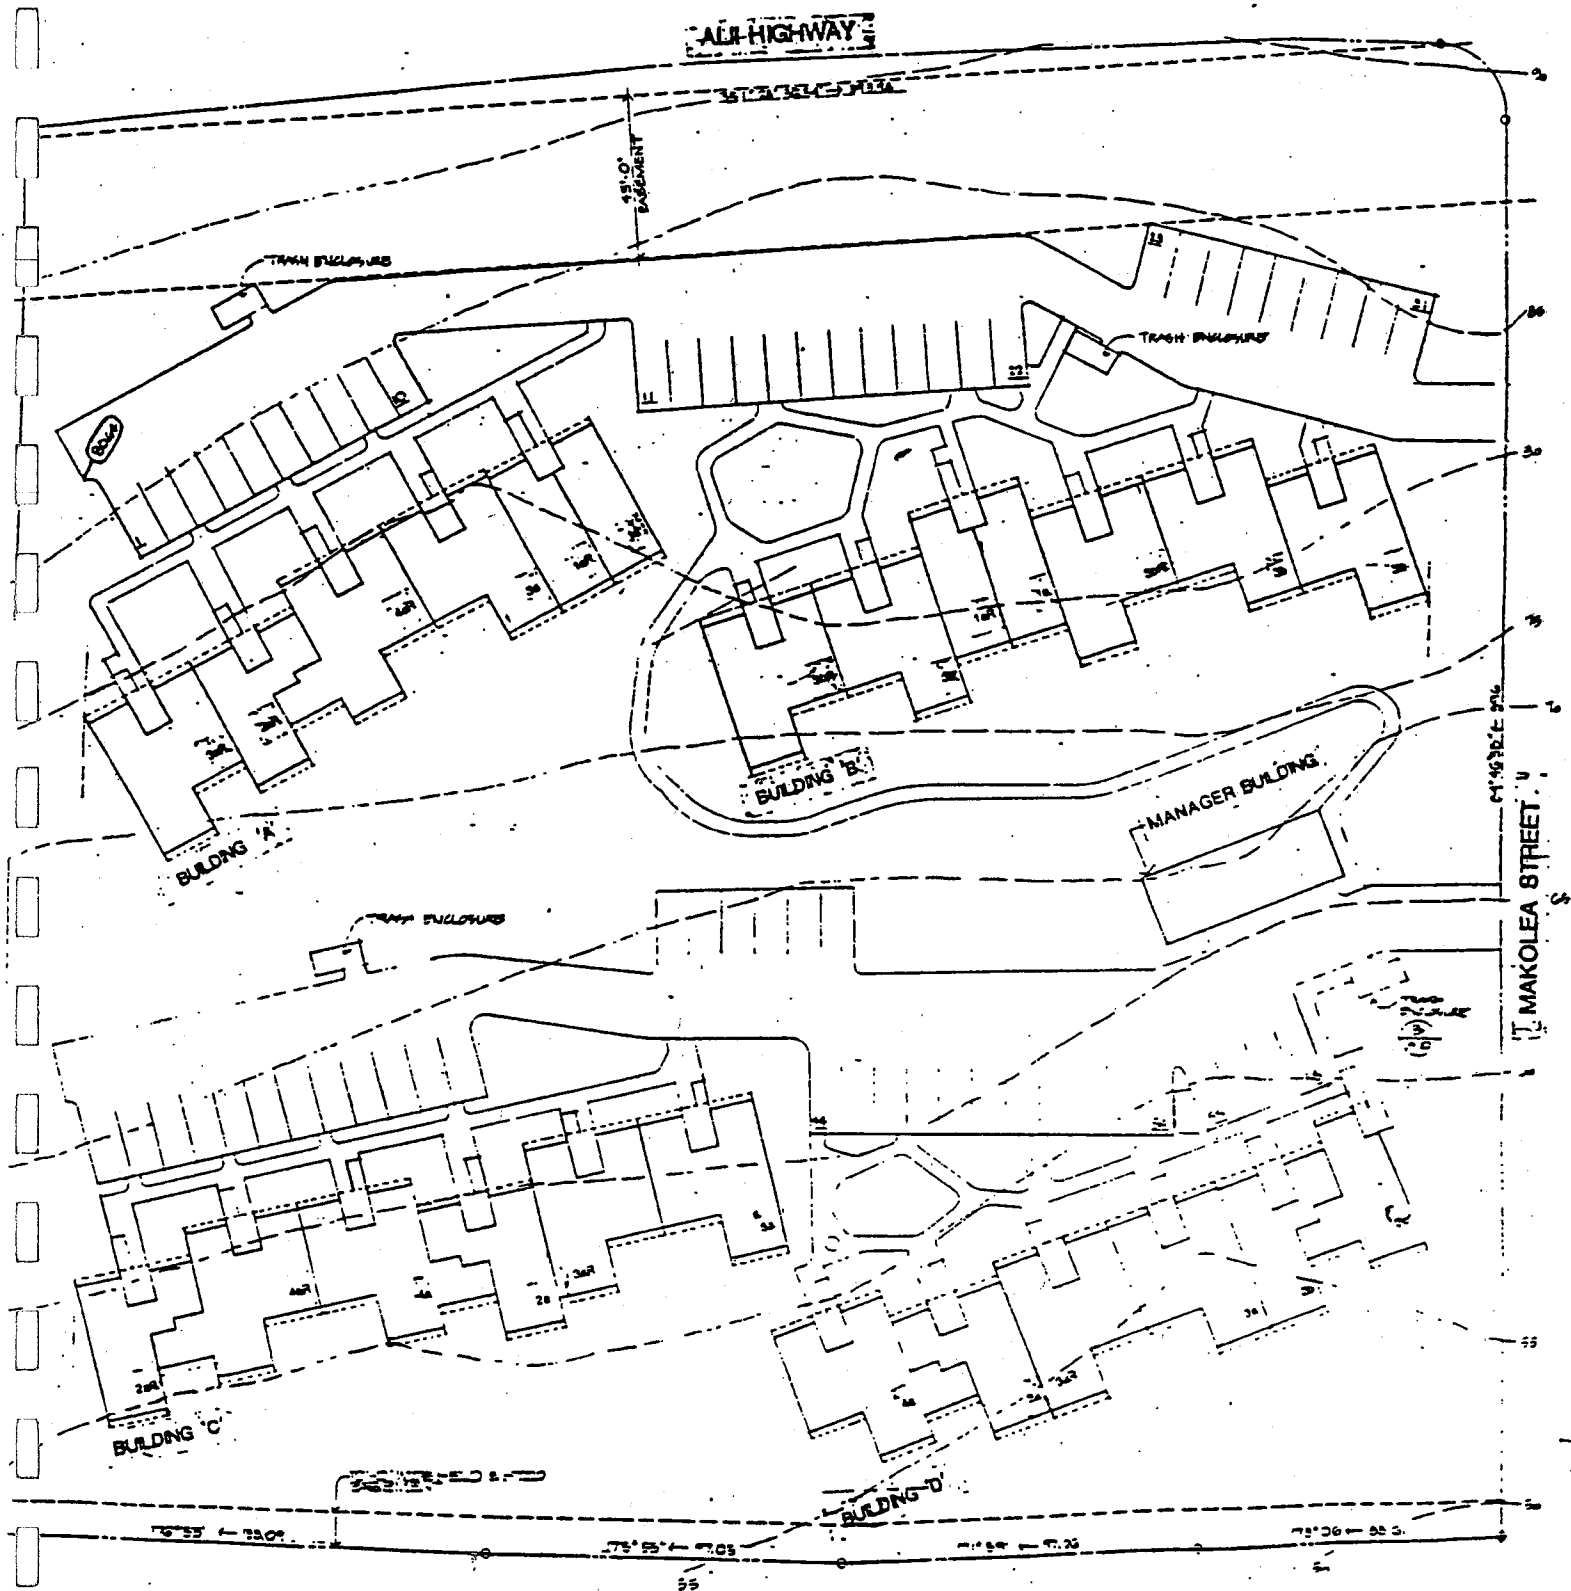
SITE PLAN

KA HALE KAHALUU
HA 1-61

HAWAII, KONA

T.M.K. 7-3-10:4

Kahale Kahaluu has 4 two story residential buildings and 1 common single story -office/maintenance building. It has two parking areas and accesses to the site. Parking areas/driveways paving and perimeter fencing are in satisfactory condition.

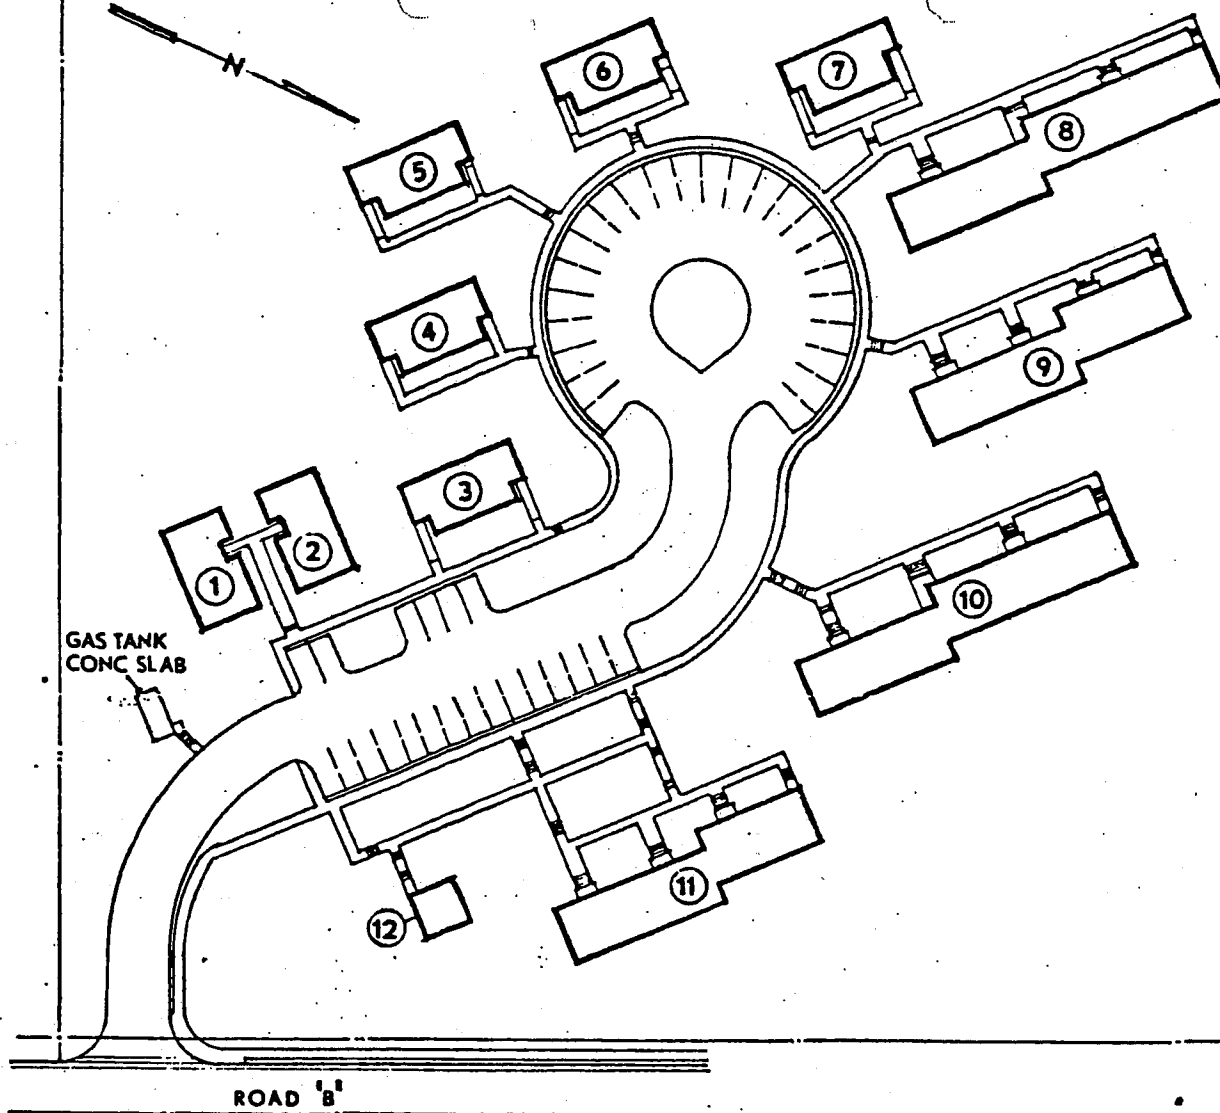
SITE PLAN
scale 1" = 80'-0"

KAIMALINO

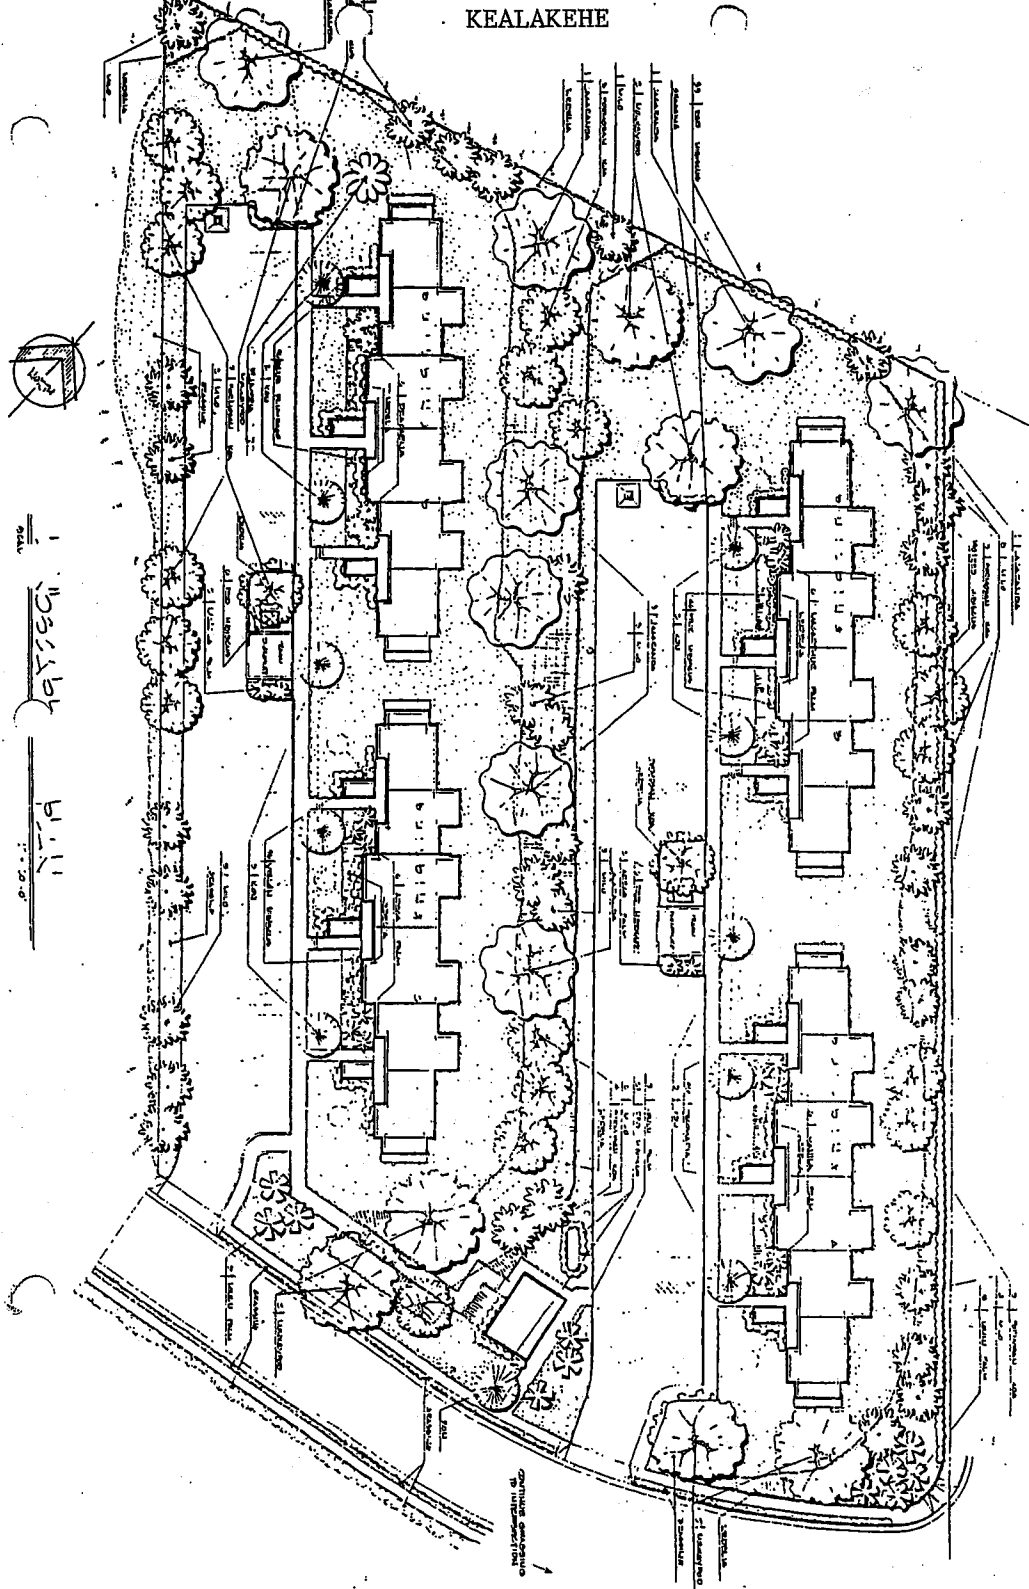
SITE PLAN

KEALAKEHE
 KEALAKEHE LOW RENT
 1-70

LOCATION: 74-991 MANAWALEA KAILUA KONA HI

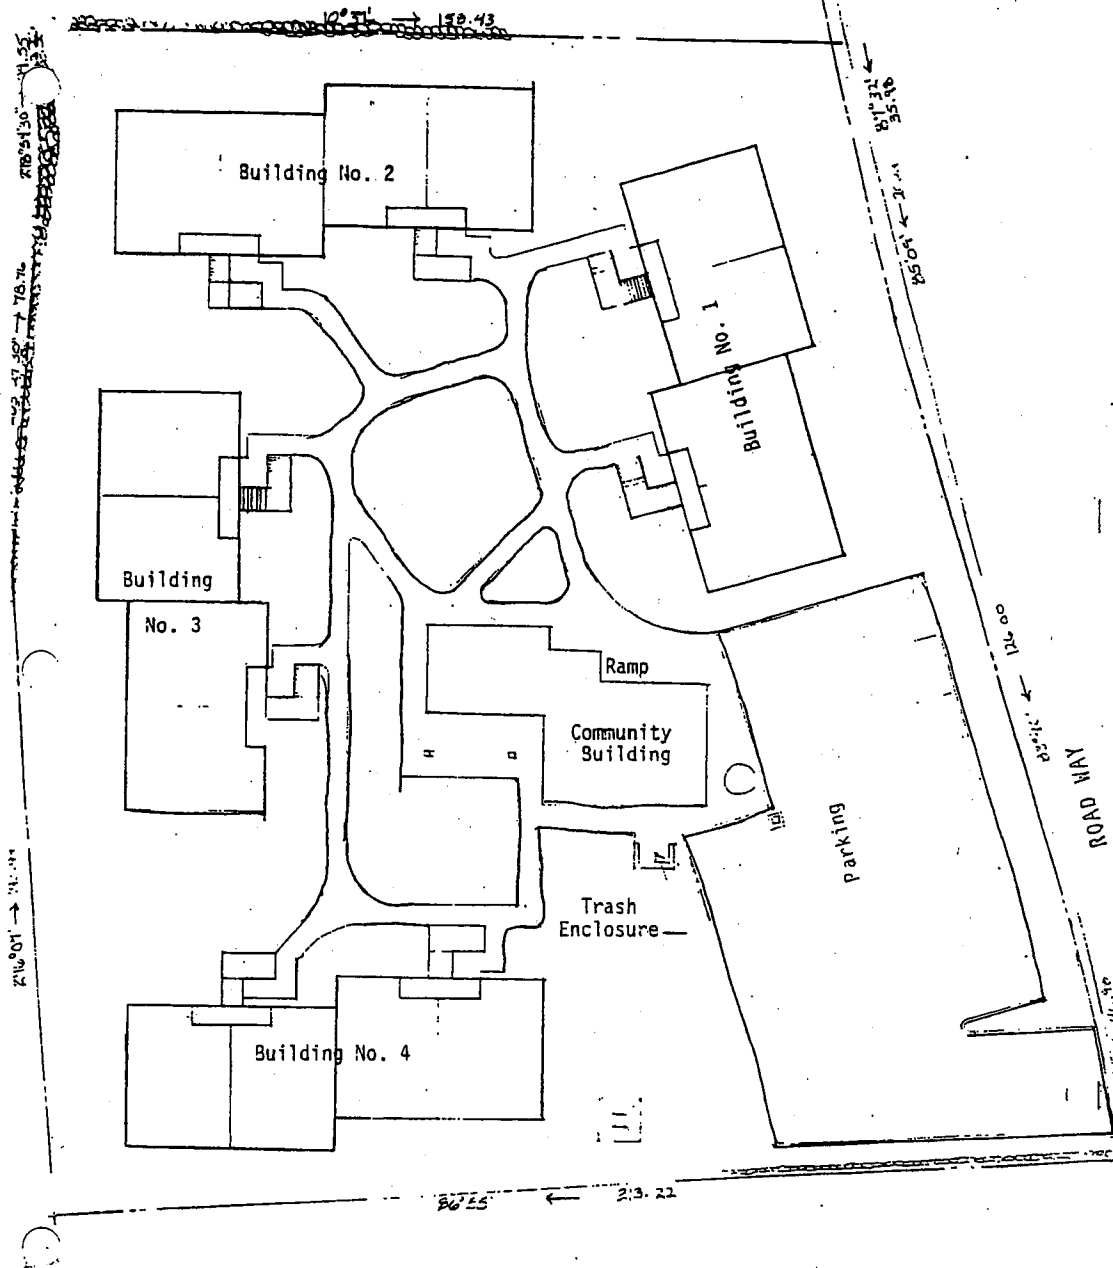
SITE PLAN

NANI OLU
HA1-63
HAWAII, KONA.

Nani Olu has 4 two story residential buildings and 1 common single story -office/hall/laundry/maintenance building. It has one parking area and access to the site. Parking area and driveway paving are in satisfactory condition. Mail boxes pedestals need to be replaced due to corrosion. 100% of site stairs railing need to be repainted due to excessive weathering. Need to repair chain-link fence along bank side. Wood fence on Kupuna Street needs to be replaced due to weathering and water rot. Trash enclosure wood bumper needs to be replaced, block walls need to be cleaned and repainted. Benches all around community building need to be repainted. Planters at rear and sides of property need to be cleaned of debris. Remove excessive plant life at rear side of property. Entry unit walkway at exterior stairs needs to be re-graded due to erosion.
